# TRANS GUYANA AIRWAYS

TGA SQAD 009/06/2026

RE: Safety Report: Escalating Runway Hazards and Security Breaches at Interior Airstrips (LTH/IMB)

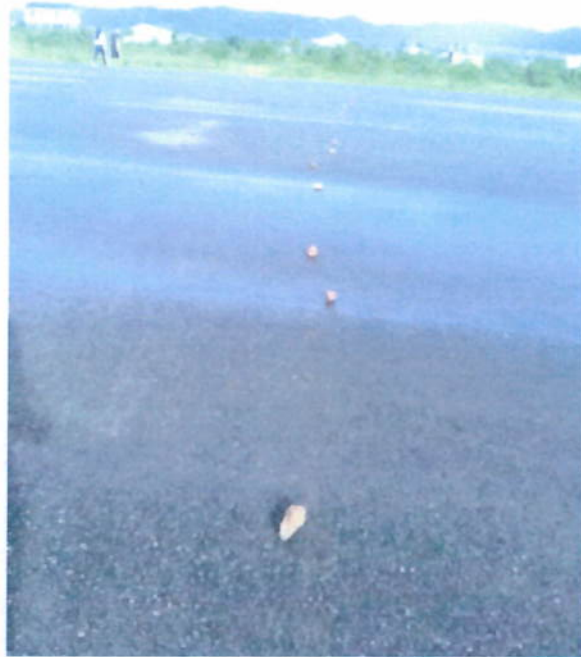
| Date | Location | Incident Description |
|---|---|---|
| 30 May | Lethem | Deliberate placement of rocks on runway. |

**Stones set across the runway at Lethem**

1. **Security Audit:** Conduct a security and physical inspection of the Lethem airport perimeter.
2. **Infrastructure Directive:** Issue an urgent order for the repair and reinforcement of the perimeter fencing and access gates at Lethem.
3. **Local Authority Intervention:** Coordinate with local law enforcement and municipal authorities to investigate the reports of deliberate obstruction (rocks/foreign objects) and enforce public access control.
4. **Enhanced Operational Oversight:** Review and bolster pre-arrival runway inspection protocols for all operators.

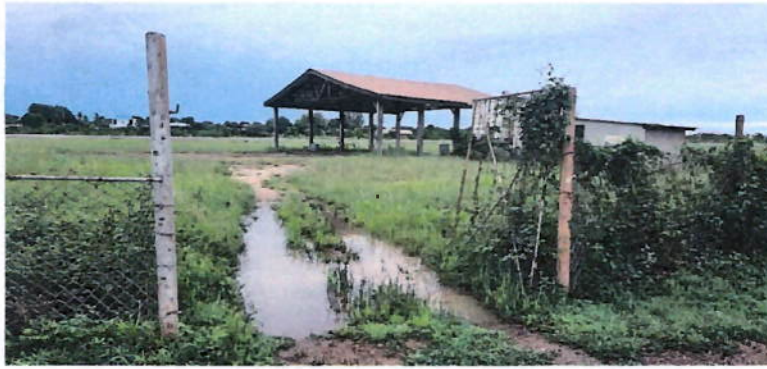
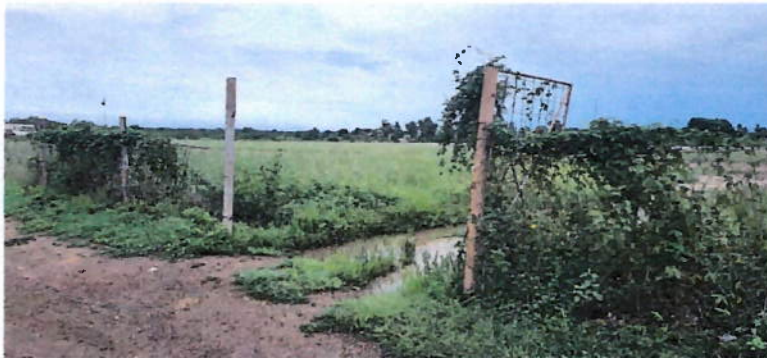
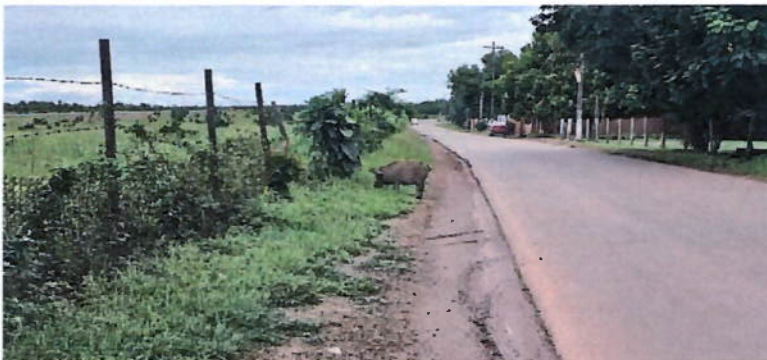
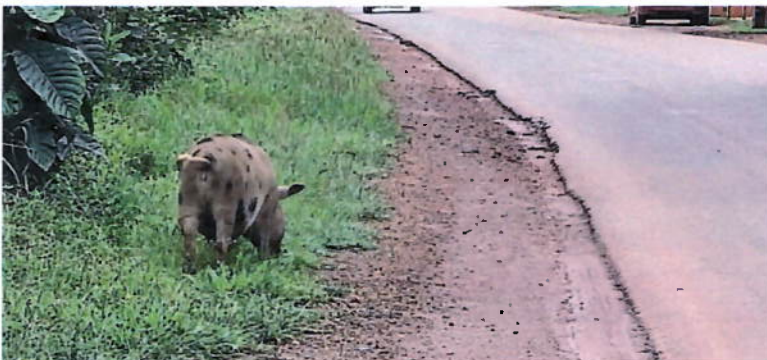
| Date | Location | Incident Description |
|---|---|---|
| 15 June | Lethem | Significant breach identified: Broken airport perimeter fence.<br>(About 14 Pigs roaming in the vicinity) |

About 14 pigs are roaming in the area

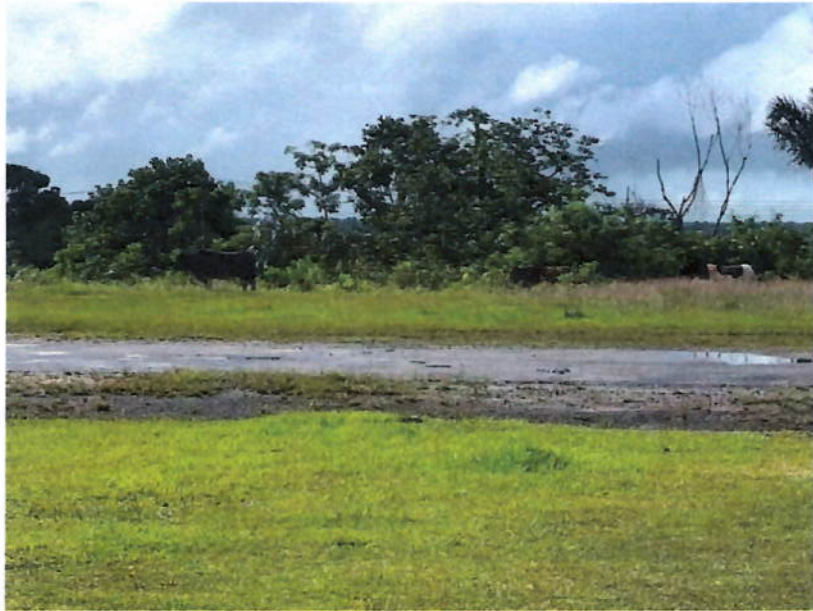
| Date | Location | Incident Description |
|---|---|---|
| 09 June | Mabaruma | Cows grazing along the side of RWY - MBU |

**Cows grazing at Mabaruma**

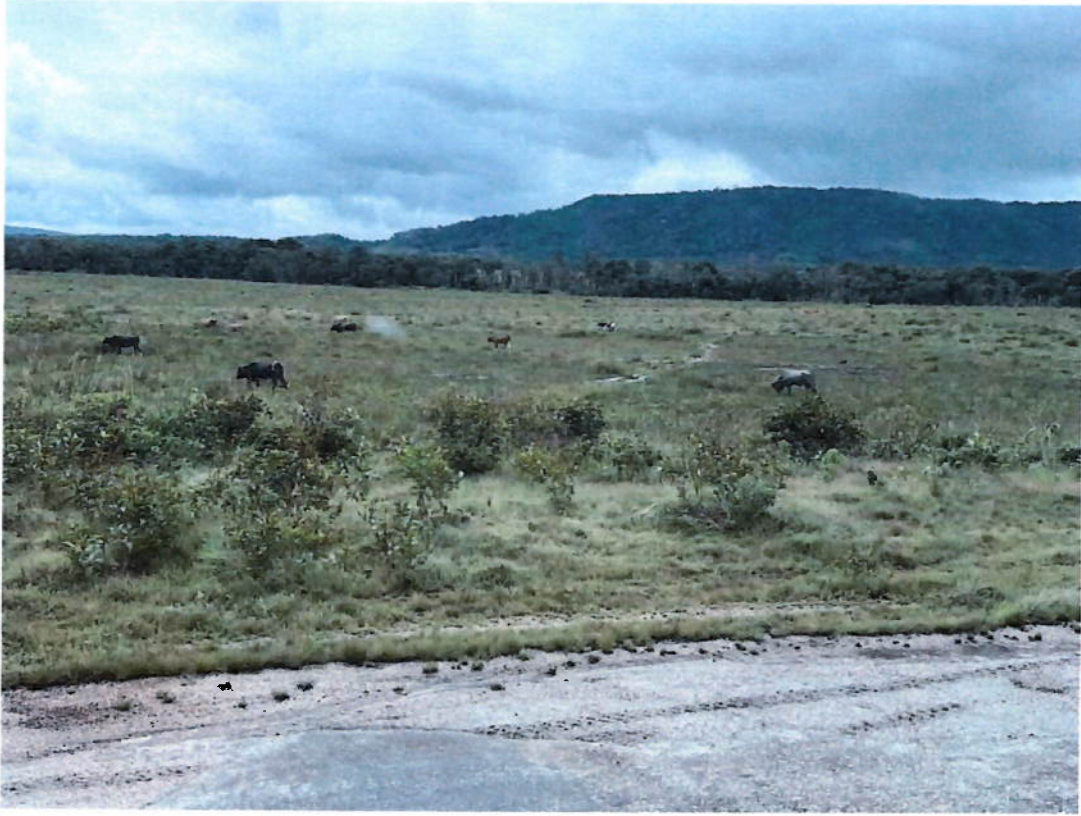
| Date | Location | Incident Description |
|---|---|---|
| 15 June | Imbaimadai | Livestock (cows) observed encroaching on the side of the runway. |

Cows Grazing at Imbaimadai
